BANK HALL

BRETHERTON

THE CLOCK PROJECT

Bank Hall Action Group

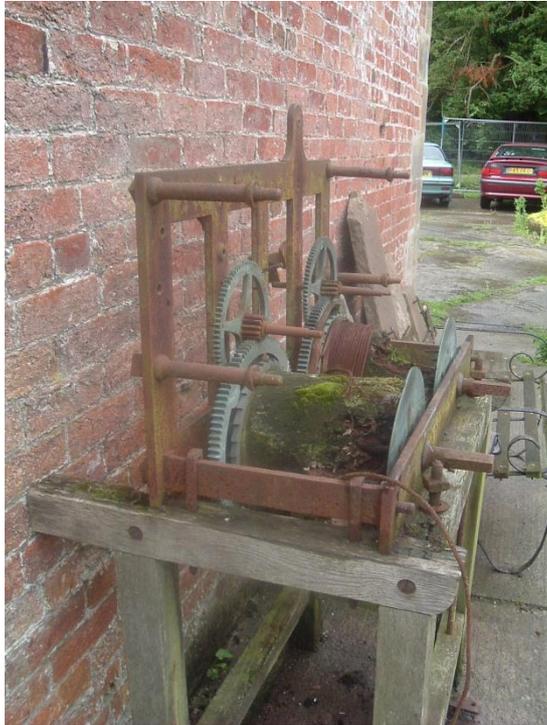
This picture shows the clock mechanism that we wish to restore as part of this project. The metal parts are not substantially corroded but the wooden drums that carry the wires, the two rollers on the right hand side and the stand itself are now in a very poor condition.

Part of the mechanism is at present outside the Hall on the hard standing on the East side of the Hall. This part of the mechanism has been robbed of all brass-work but contains the wooden drums on which the steel weight cables were wound. The wooden stand needs to be replaced as it is rotting away as do the wooden drums. Since the picture on the front page was taken, vandals have pushed the stand over and it has had to be dismantled. The remaining metal work needs to be preserved and a new stand constructed. Other parts of the clock are within the Hall and need to be located and preserved.

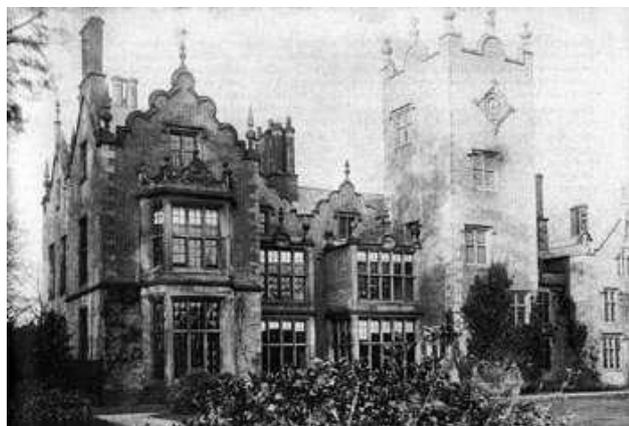
This picture is from the earlier part of the 20th Century, and is of the rear of the Hall which faces south. The Clock face can clearly be seen at the top of the Tower. The face that is shown is still in-situ on the Tower except for the loss of the two fingers.

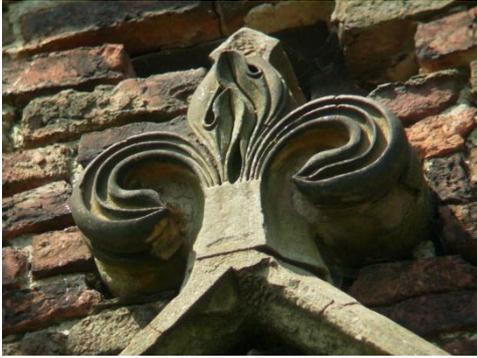
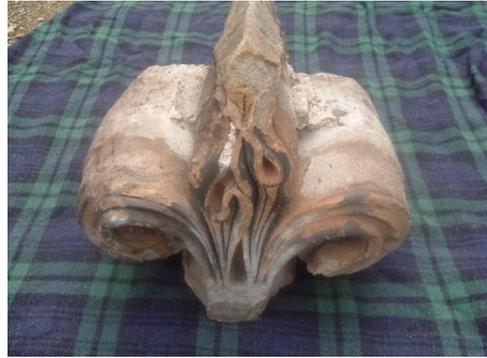
The Clock faces are constructed in a diamond shape using 4 pieces of stone. At each corner there is another large piece of Sandstone faced on the front with a Fleur-De-Lys. One of the Fleur-De-Lys stones on the North face was still on the Tower but fell down in Summer 2009. Another one in slightly better condition has been recovered and is with the Groups Artifacts but is also deteriorating. A third has been located within the Hall but is in very poor condition and the fourth is missing.

The left hand picture below is of the Fleur-De-Lys which is above the top corner of the clock face. The right hand picture is of one of the Fleur-De-Lys from the North facing clock face. This item is currently with the Group's artifacts. Pictures were taken June 2008 and August 2007.

- The first element of this part of the project is to replace the four Fleur-De-Lys with new stone work if necessary which will of course have to be sourced, cut and faced to the same specification as the former ones.
- The second element of this part of the project will be to repair and, if necessary, replace the sections of the clock face if they are found to be damaged or the facing is found to have deteriorated.

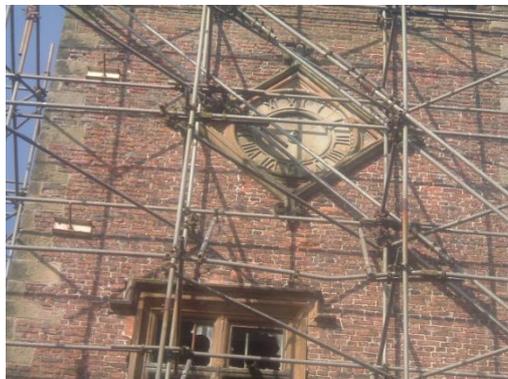
Currently, the clock face on the South facing side is still intact except that in spring 2007, vandals climbed the scaffolding and ripped off the clock fingers. One of the fingers was dropped and was subsequently recovered albeit in a damaged state and that is now with the Groups Artifacts. The face on the North side fell when the North side of the Tower collapsed.

This picture shows the existing clock face as it appears - October, 2007, on the south facing side of the tower.

The second part of the project is to replace the Clock fingers for both faces of the Clock and to preserve what remains of the Clock mechanism
